I took a measurement one day and the next day the measurement looked different. How can that be? Let's take a look at this measurement and try to see what's happening.

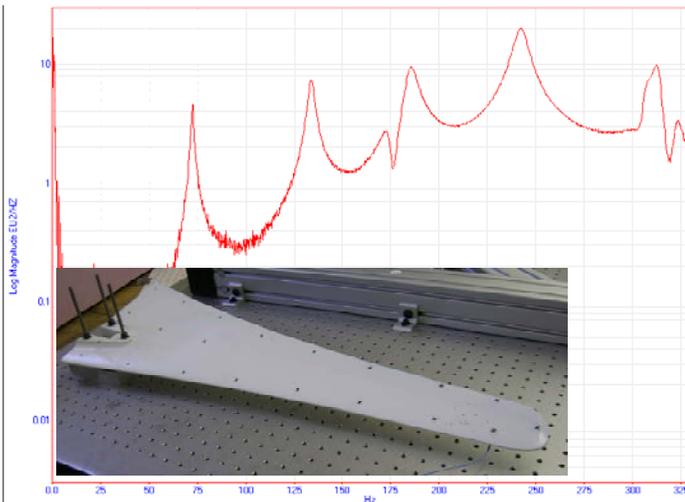
Figure 1 – FRF and Test Set Up - Friday

So the first frequency response function was made with the blade attached to the optical table. Normal impact measurement methodologies were employed for the impact and response measurements with an FFT analyzer. The blade was attached to the optical table with a solid mounting block and some threaded

rods to attach the block (as a spacer) between the turbine blade and the optical table; this was necessary due to the curvature of the blade geometry to allow for clearance between the cantilevered blade and optical table.

Overall the measurement looked acceptable and the coherence for the measurement was also acceptable. The frequency response function is shown in Figure 1 with a picture of the test set up. The low frequency portion of the measurement was not of interest and is hidden behind the picture of the test set up.

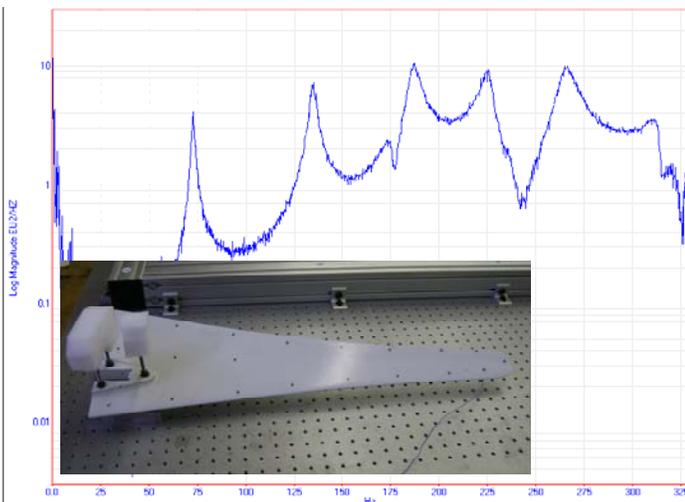
Figure 2 – FRF and Test Set Up - Monday

So the first measurement taken appeared to be acceptable. Now this measurement was taken on a Friday afternoon followed by additional testing to be performed the following week. As good practice on Monday morning, the measurement was repeated prior to the balance of testing to be performed. This second measurement also looked acceptable overall. The frequency response is shown in Figure 2 with a picture of the test set up. Again the low frequency portion of the measurement was not of interest and is hidden behind the picture of the test set up.

Well as it turns out, the lab manager was very concerned about safety and the three threaded rods that protrude from the blade and block attaching it to the optical table could cause some injury if someone wasn't careful around the test set up. So as a precaution, the lab manager had some soft foam pushed onto the long threaded rod. (Now this foam is basically the soft packing foam that you find in packaging of electronics and is extremely light and really has no structural effect whatsoever.) BUT...

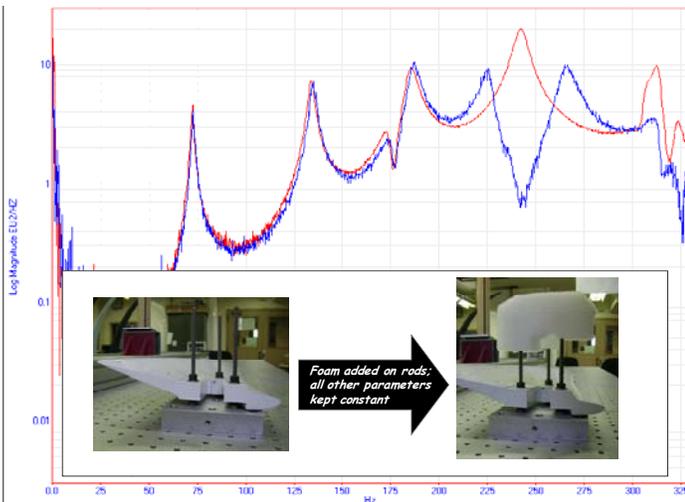
Figure 3 – Comparison of Friday and Monday Measurements

But the measurement taken on Monday morning did not look the same as the measurement taken on Friday which had several people scratching their heads. Figure 3 shows the comparison of two measurements overlaid.

Fortunately someone recognized these dramatic differences and stopped testing to determine what could have possibly caused such a dramatic difference in the measurement. Figure 3 clearly shows that the lower frequency modes are essentially the same with normal variation which is to be expected. But the higher frequency range had a dramatic difference in the measurement, almost as if it was from a completely different structure.

That foam does have a very, very small amount of mass and at the end of the long threaded rod has the effect of changing the cantilevered mode of the threaded rod. And oddly enough, the effect of shifting that cantilevered rod frequency just happened to coincide with one of the natural frequencies of the blade. This then caused the two modes to split in a very traditional tuned absorber effect. And this effect was very dramatic for sure.
